Lakes Environmental Association  
2019 Water Testing Report

Chapter 5—Spatial Water Quality Mapping

# Spatial Water Quality Mapping Project

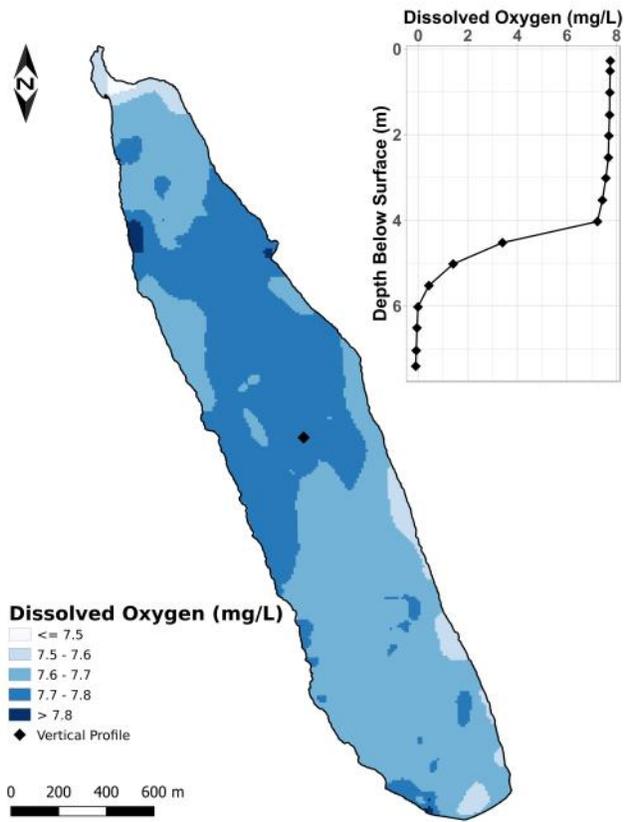
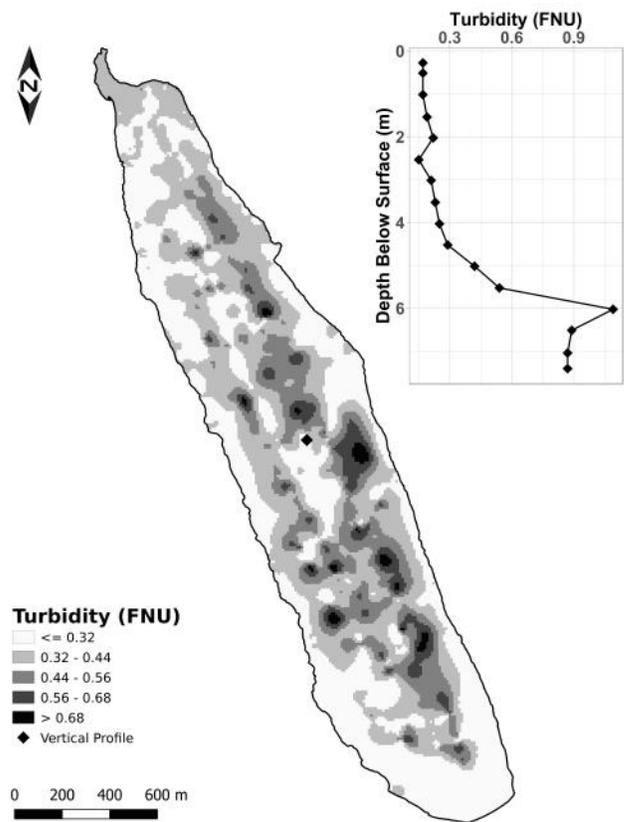
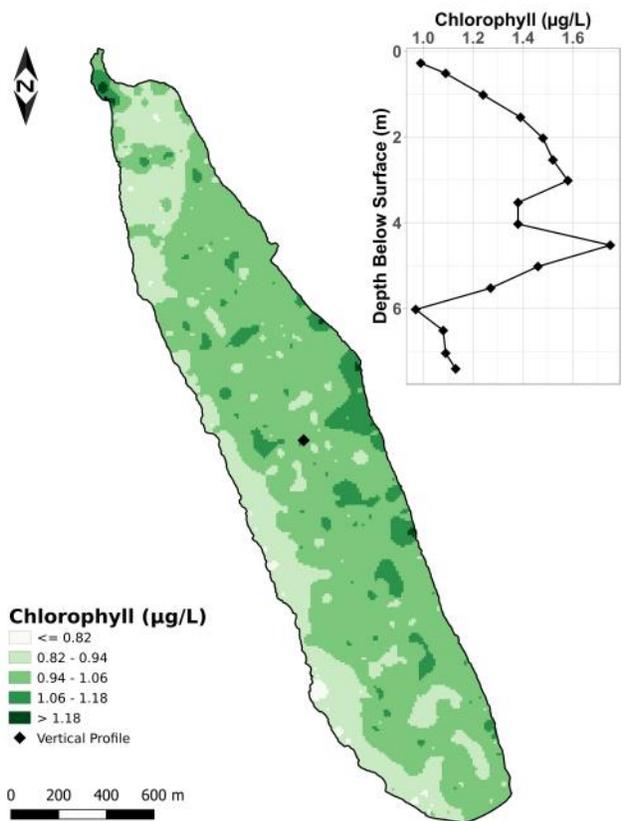
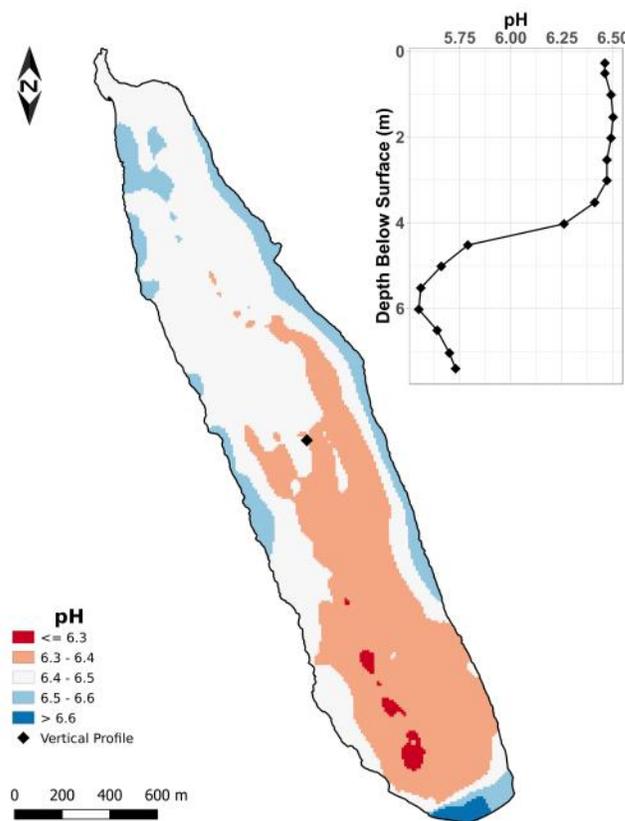
# Woods Pond - August 9, 2019

The Woods Pond survey was completed in early August in just over three and a half hours during the middle of the day; almost 10400 data points were collected. Weather was sunny, clear, and warm, with a moderate north-northeast wind. Boat traffic was heavy and produced many waves that forced occasional speed and course corrections. Variation for all parameters was mostly greater with depth than across the surface. The variation in surface water temperatures was only about one degree, with cooler water along the southeastern shoreline (a possible artifact of starting the survey in the morning along this shaded side). The western shore could have warmed up more quickly to produce the observed pattern. A boat track pattern was visible in data also. Dissolved oxygen varied within a small range and some features could be explained by localized plant patches, or in the case of the northern inlet, a source of organic matter to cause oxygen declines. The turbidity map was very patchy and most likely caused by bubbles that developed in the flow-through system. Chlorophyll concentrations were a bit higher than the other surveyed lakes, but did not vary that much over the whole lake; subsurface chlorophyll was only slightly higher than the surface. The lake appeared to be mostly below neutral pH, with a north to south gradient of decreasing (more acidic) values. The cause of this is unknown, but the natural organic matter that colors the water tends to be acidic. Patch size ranged from about 70 to about 860 m.
